### Canon 814E light meter manual malfunction repair . Manual iris function repair.

Canon 814 AUTO ZOOM ELECTRONIC(814E), I like this. A friend asked me for the repair because the manual iris was strange. The auto is Ok. The manual seems to move. However, it moves only to F8~11. And, it slowly returns to F4~5.6 when the hand is separated.

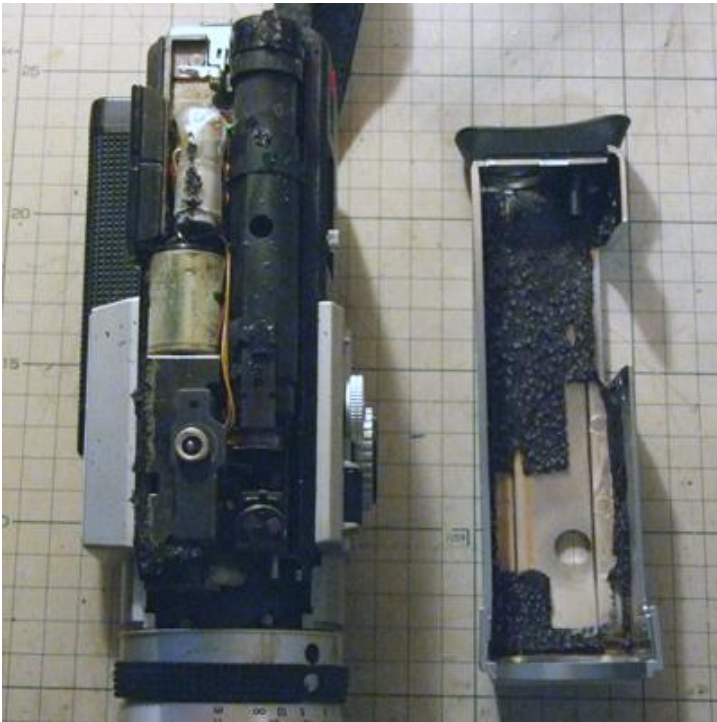
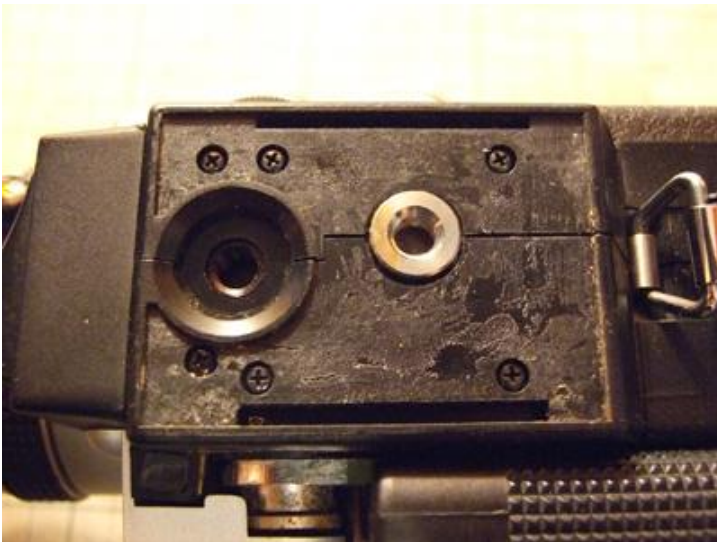
The top cover has been removed. The malt sponge is terrible. This needs to be completely reupholstered.

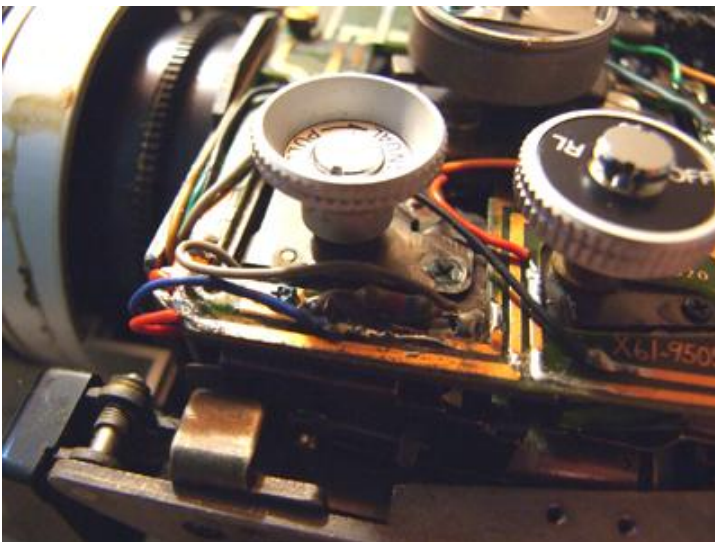
I tried moving it, but the symptoms did not change. What I found out was that if I pulled it tightly, I could move the aperture manually. Looking through the gap, it seemed like the dial was slipping when in manual mode.

The manual iris was Ok when making efforts and pulling it. The dial seems to slip when seeing from the space.

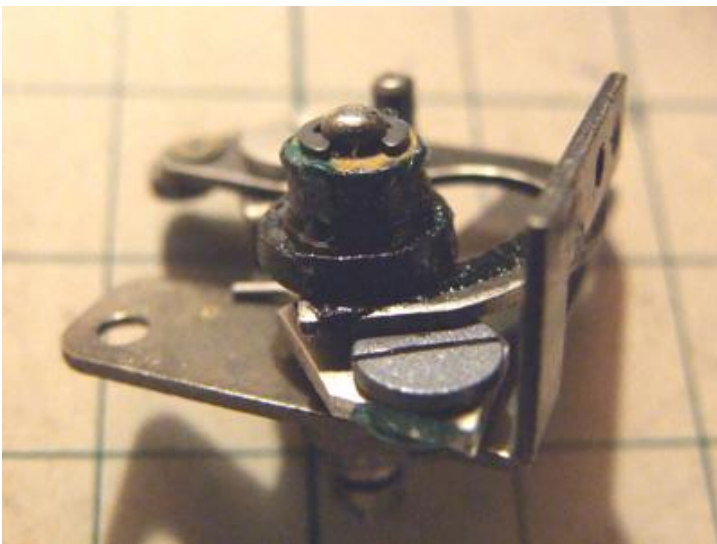
I was able to remove it safely. The rubber had deteriorated and was sticky.

It was possible to remove safely. There is melting rubber.

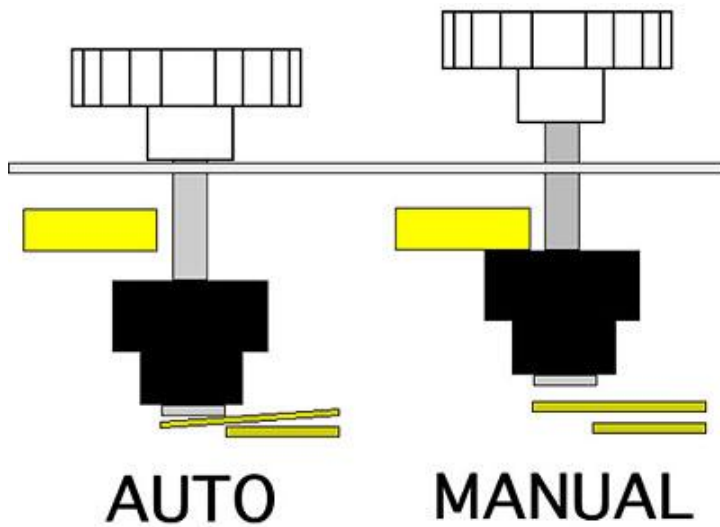
A simple drawing shows this.

The black part is rubber, and the yellow part is metal. The metal part has a jagged edge.

This friction is what moves it when in manual mode. It's actually a little more complicated, and it's linked to the mechanism that moves the aperture and the needle in the viewfinder. There's a spring there. The rubber had deteriorated and slipped, and it was losing to the force of the spring. I could barely move it by pulling it tightly.

If it deteriorates further, I think it probably won't move at all.

The black is rubber, and yellow is a metal. There is a ditch on a metallic side.

The manual iris is moved by rubbing rubber and the metal.

The thing is complex a little more. There is a mechanism that moves the needle in the iris and the viewfinder. There is a spring there. Because rubber had melted, it was defeated at the power of the spring.

I think that it becomes impossible to move at all when deteriorated more.

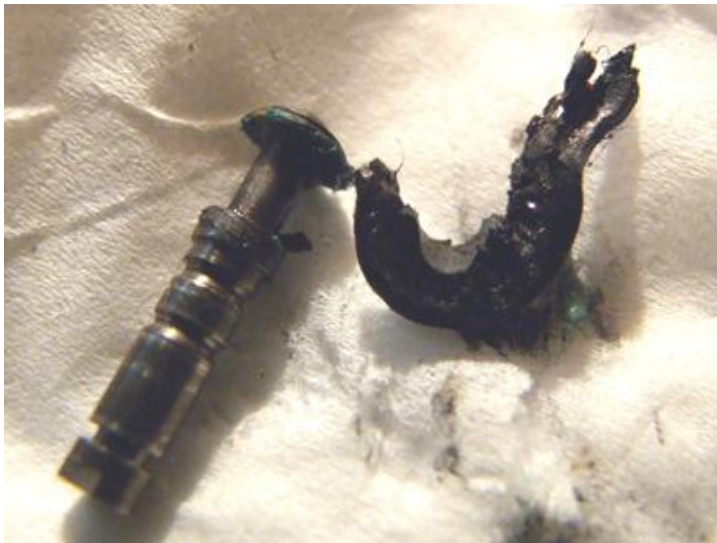
It's sticky.

When rubber deteriorates, it either hardens or melts, but I really hate the melted part... It's the worst because it's hard to get off if it gets on your hands. Many

It is a sticky paste.

Rubber melts or becomes hard. Melting is truly unpleasant. It is not possible to take it easily when touching. It is a nightmare.
